Manhole Inspection Summary

Manhole # S49II_008MH

Insp Date: **5/14/08 12:55 PM**

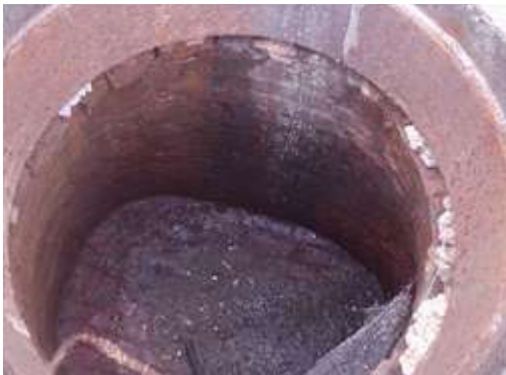
Defect 2

Condition: ☐ Sound ☐ Cracked ☐ Root Intrusion ☒ **Loose Brick** ☐ Deteriorated

loose bricks

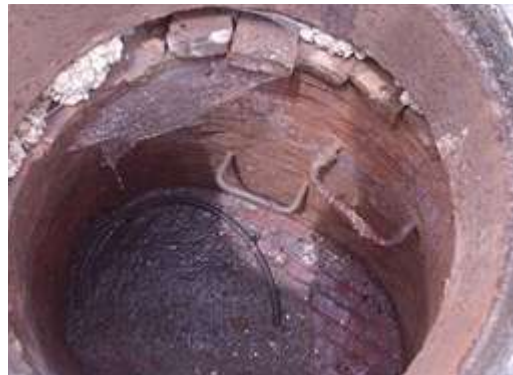
Defect 1

deterioration

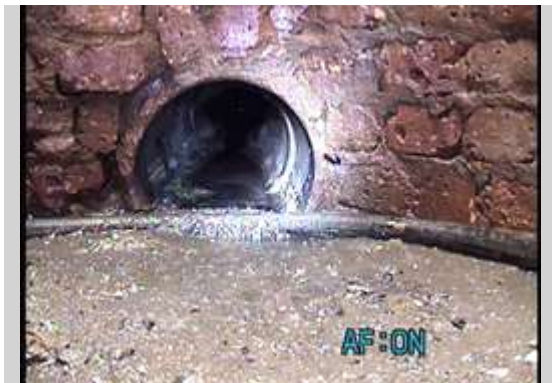
12 O'Clock Outflow

8 in. Circular Gravity Sewer
Pipe Out @ 12 O'Clock

Infiltration: **None** Pipe Seal Cond: **Sound**
